# Supplemental LGC Geotechnical Letter Reports

Project No. 10106-01

**Subject:**        *Location of Whittier Fault, Cielo Vista, Tentative Tract Map No. 17341, County of Orange, California*

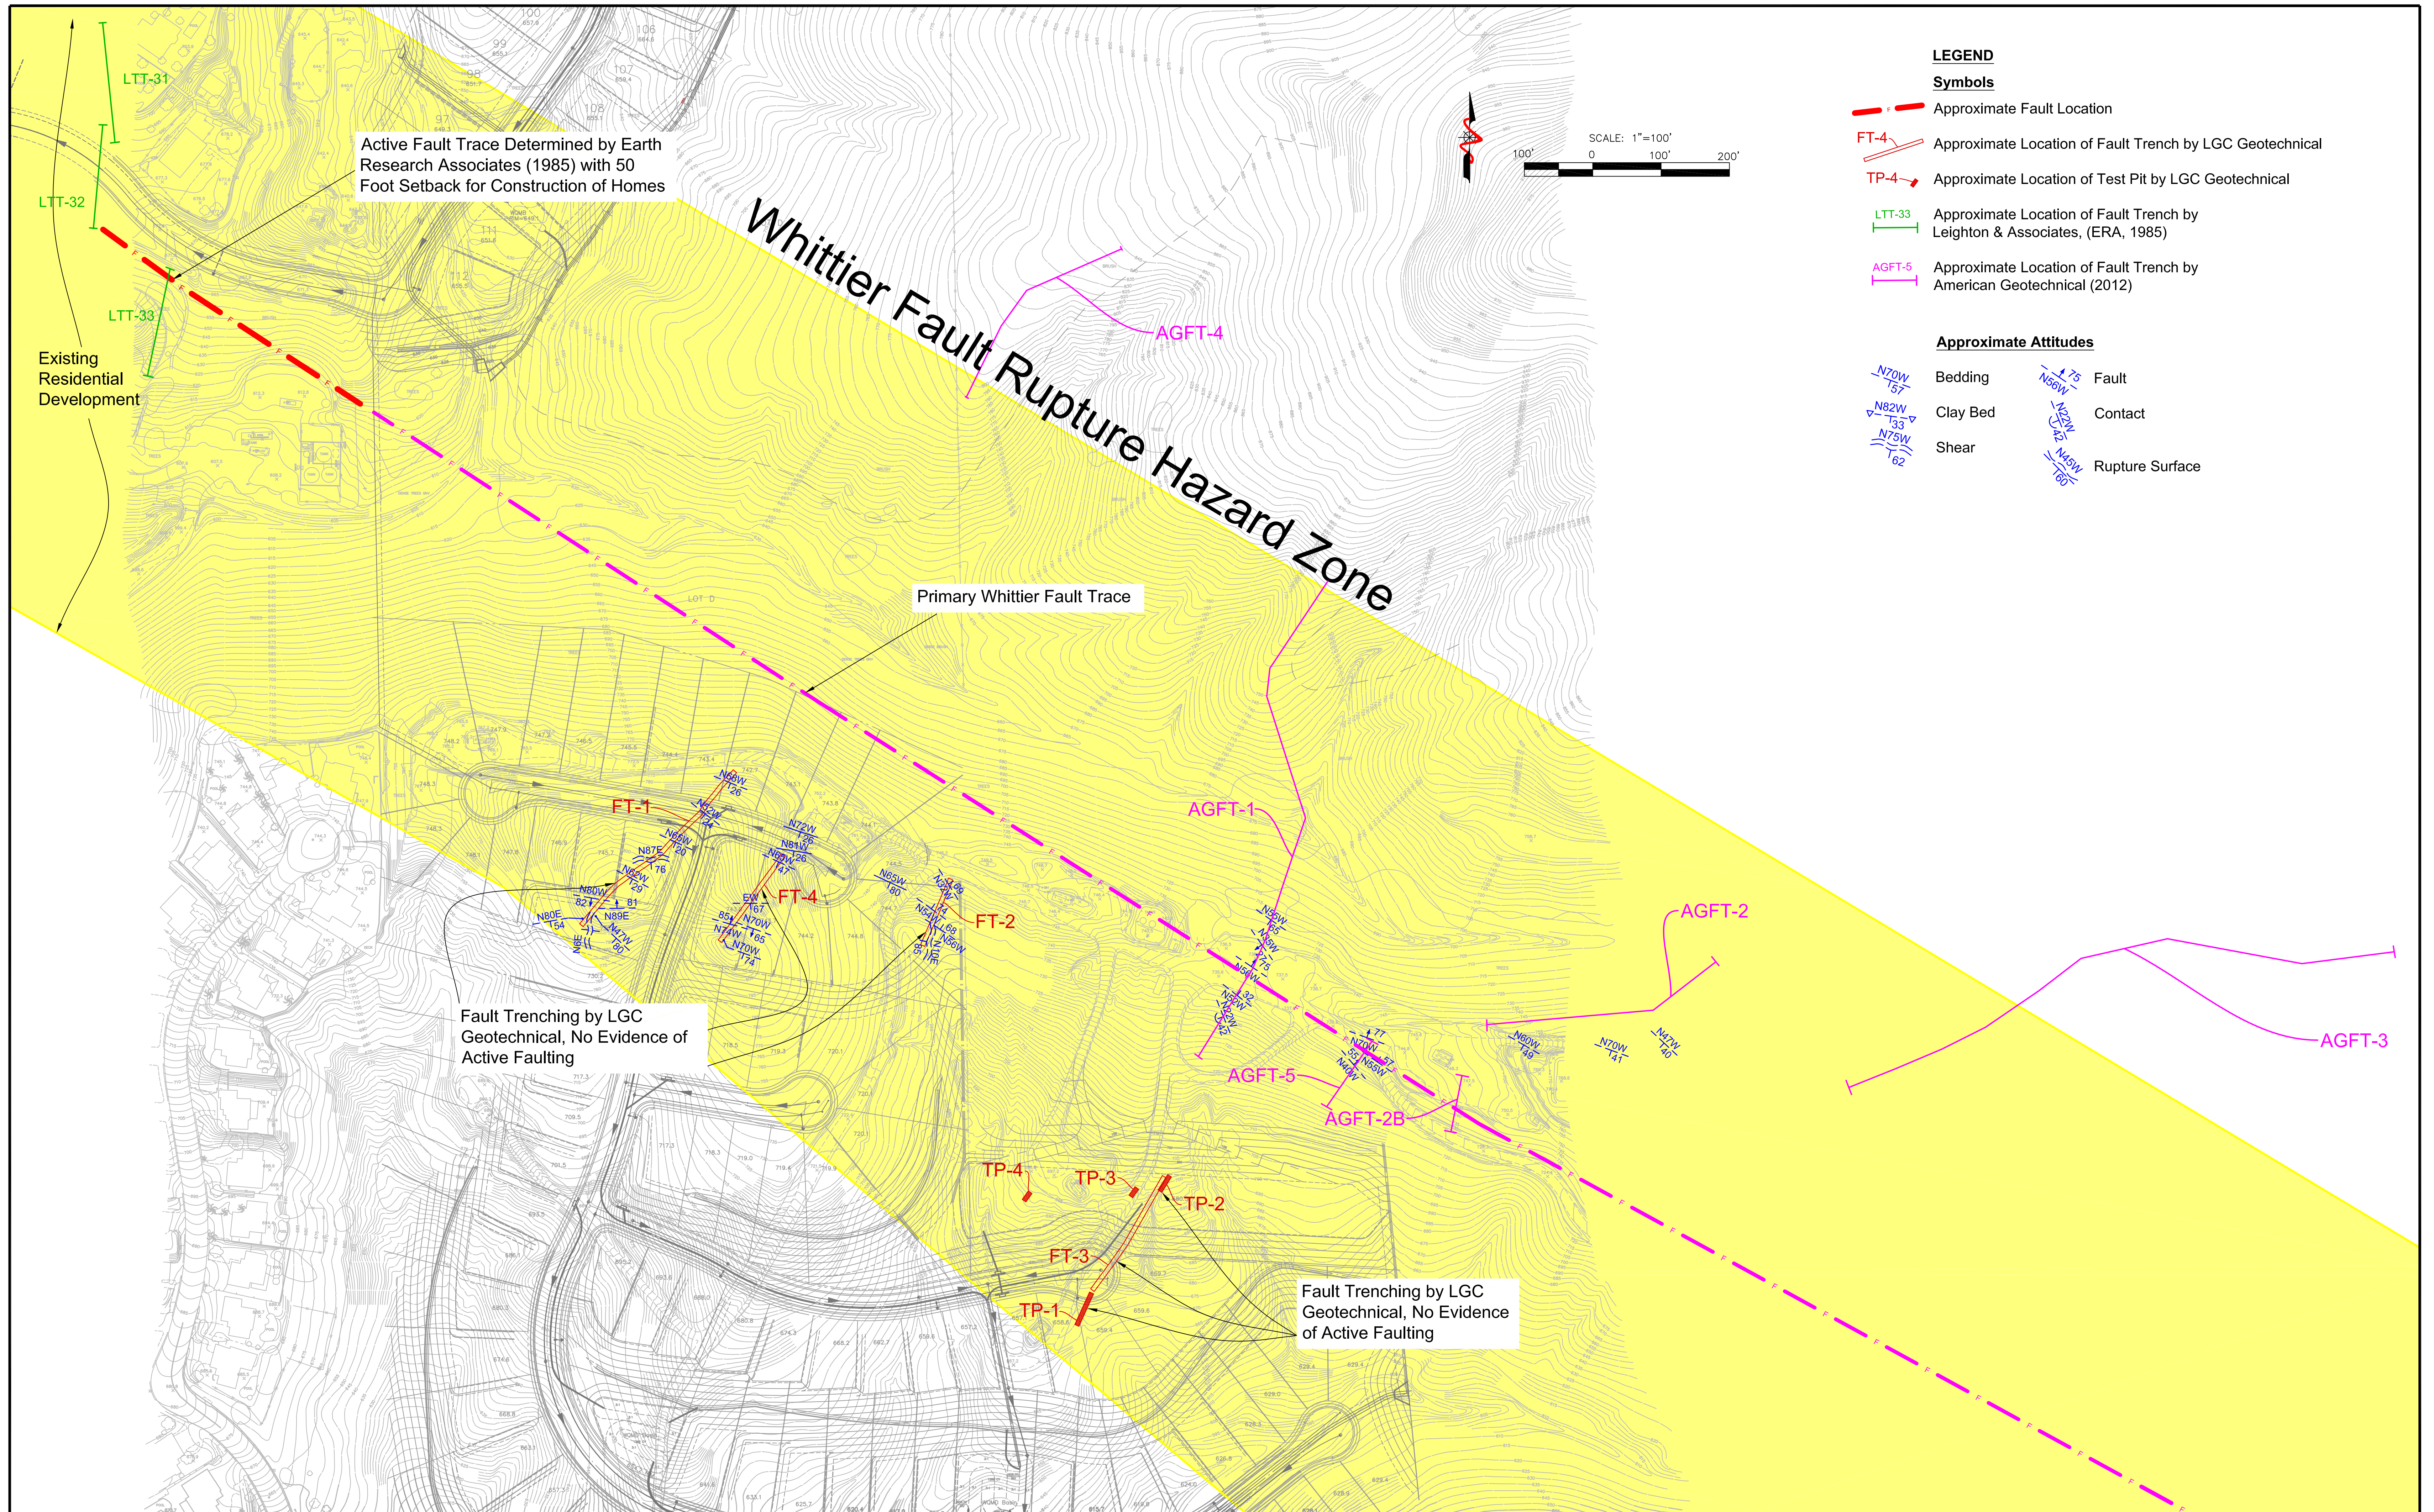
**Whittier Fault Location Map**

The primary trace of the Whittier Fault is well-defined as a narrow fault zone less than approximately 15-foot-wide along the east-west drainage in the central portion of the Cielo Vista site as depicted on our Whittier Fault Location Map (Sheet 1). The findings of our study are in general concurrence with the findings of the previous fault studies in the vicinity of the subject site, including the recent fault study performed east of the site prepared in connection with the Esperanza Hills development (AGI, 2012). The fault trace location was established by projection of the fault trace across the site using the fault trace locations established at the eastern and western property boundaries of Cielo Vista.
