August 1, 2014

Project No. 10106-01

**Subject:**        *Discussion of Potential Implications of Subsurface Geological Features in the Southern Portion of Cielo Vista, Tentative Tract Map No. 17341, County of Orange, California*

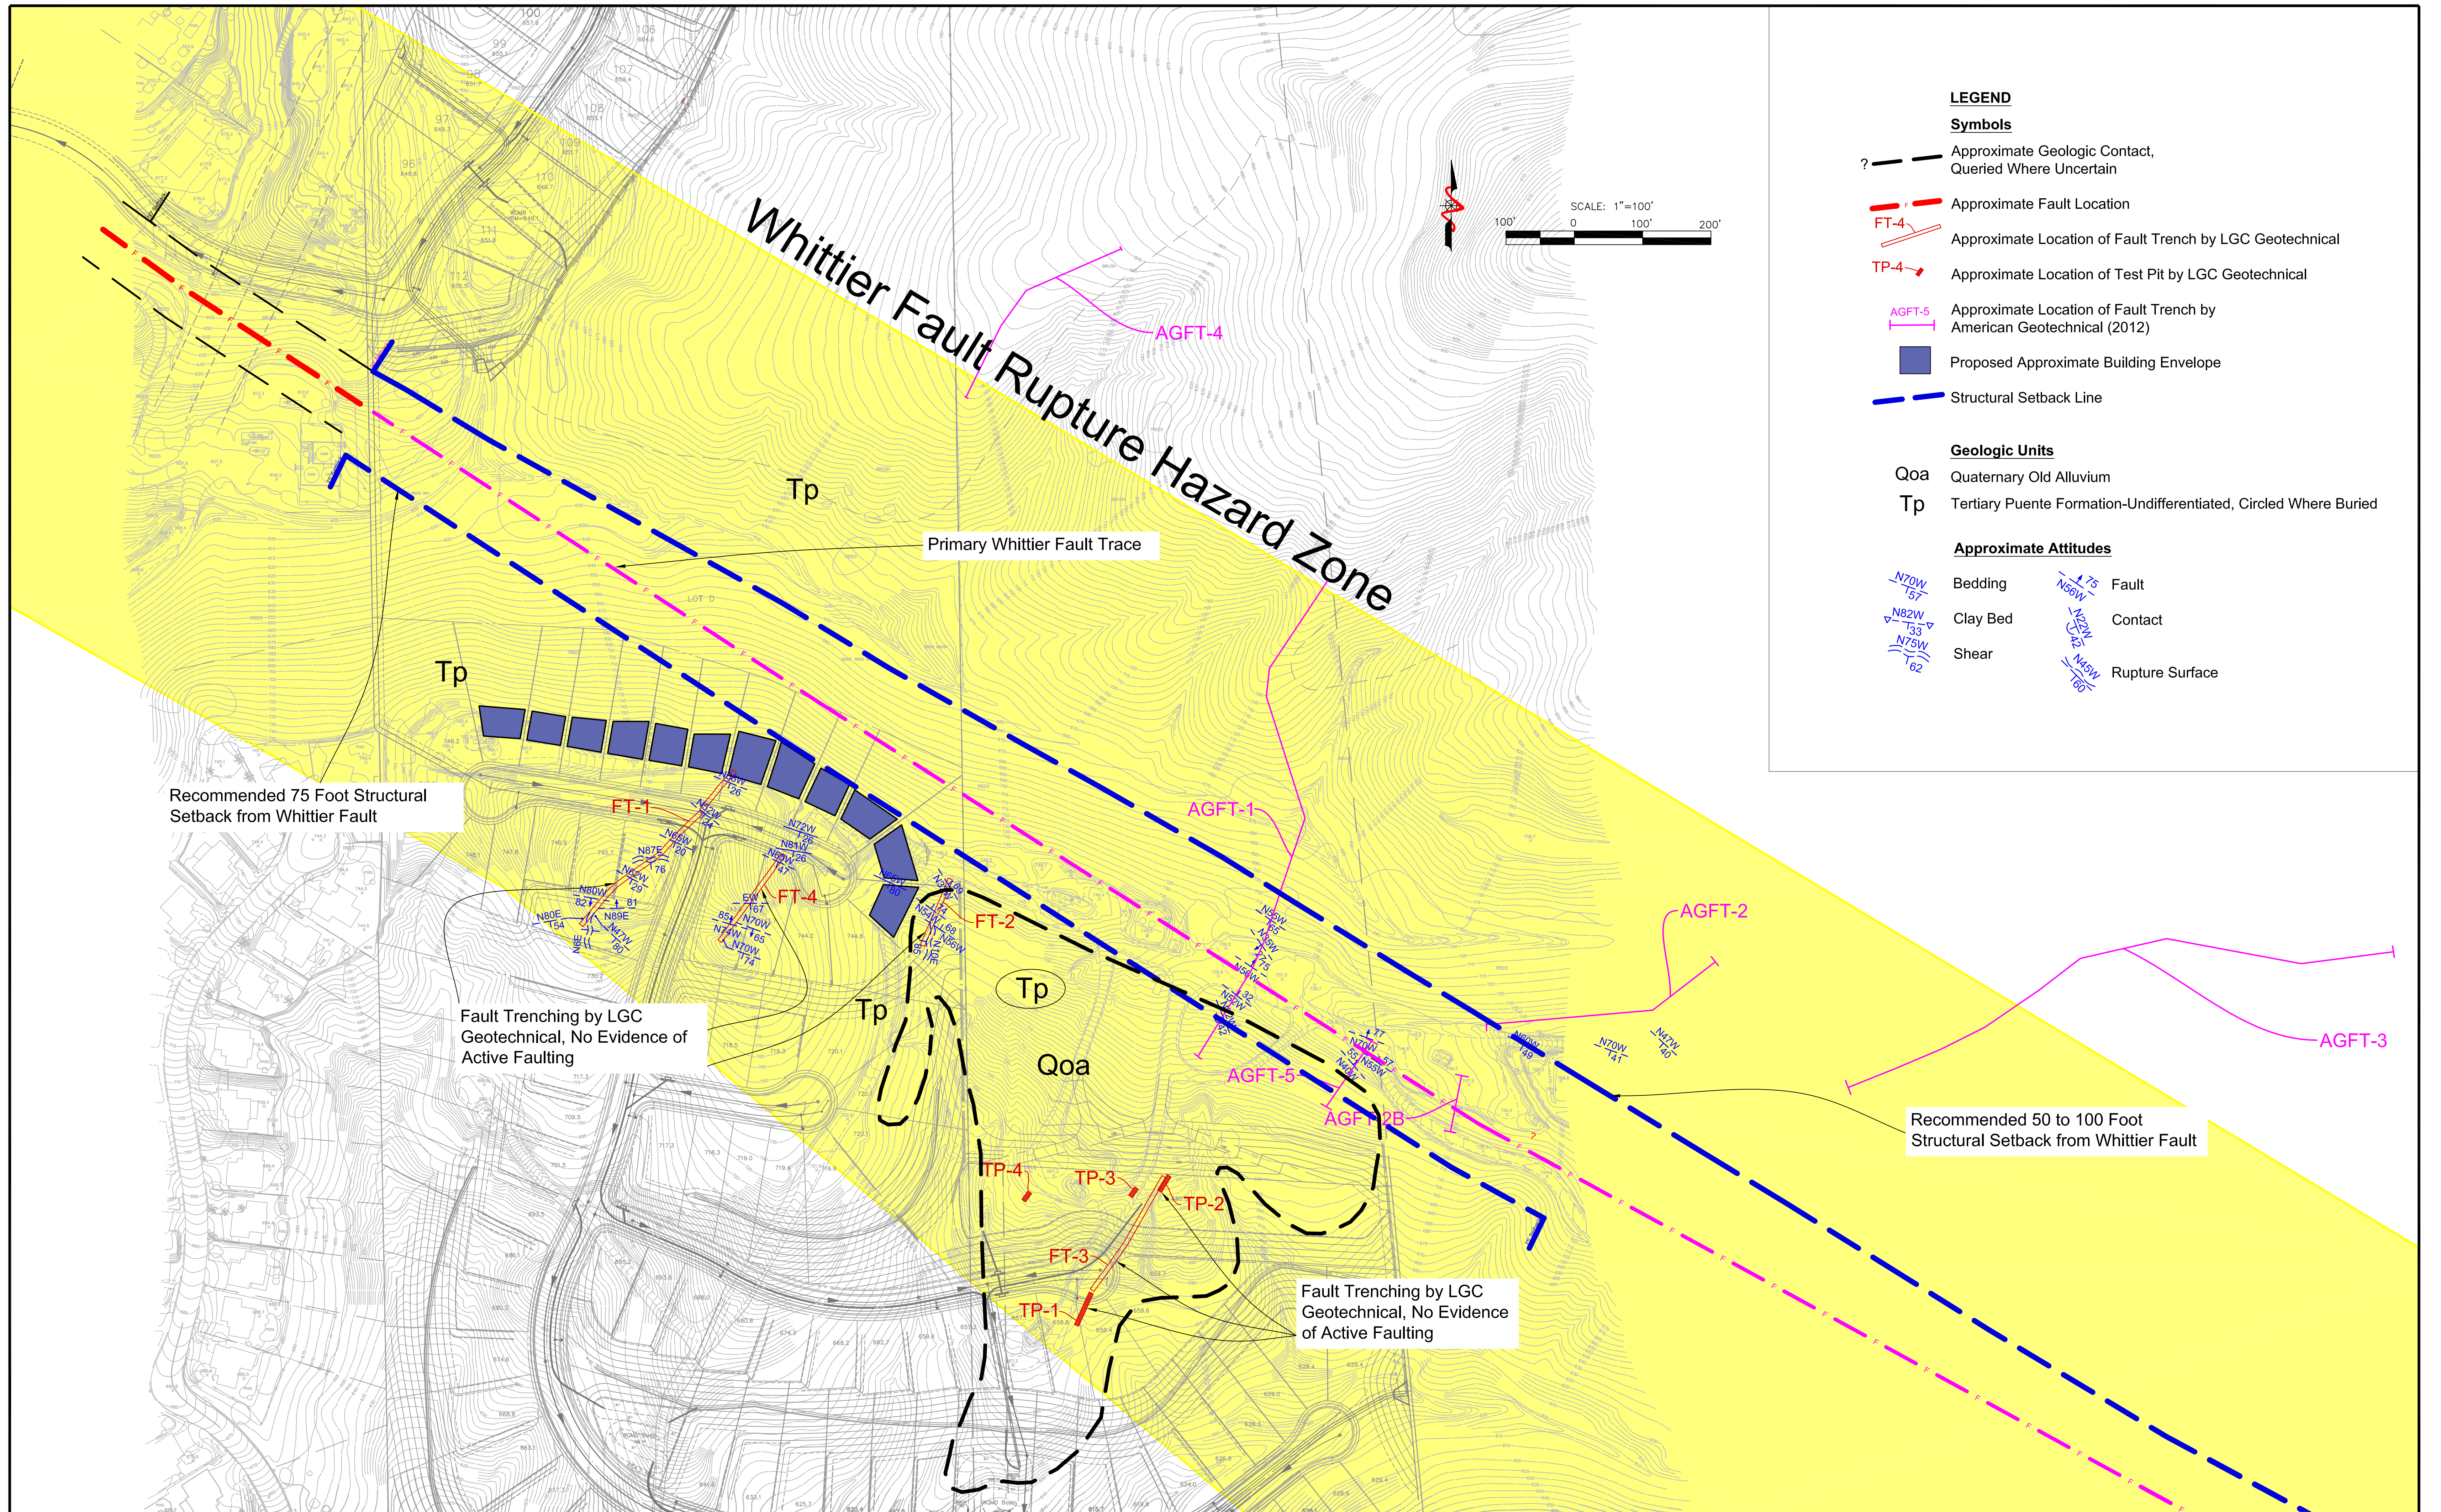
**Whittier Fault Setback Map**

Our review of fault trenching performed east and west of the southern Fault Rupture Hazard Zone on the site has indicated the absence of active faulting projecting towards and within the southern portion of the Fault Rupture Hazard Zone. Although we have identified subsurface geological features in Fault Trenches FT-1

and FT-4, these faults are well south of and subparallel to the primary trace of the Whittier Fault and are not considered to be the active trace, nor active branches of the Whittier Fault. Rather, the features in Fault Trenches FT-1 and FT-4 are likely older faults related to "ridge shatter" as the ridgeline in the central portion of the site was uplifted and the geology folded.

To build residential structures within the Southern Fault Rupture Hazard Zone Area, it needs to be demonstrated that the area of proposed development is not underlain by an active fault (CDMG, 2007). A fault that has ruptured the ground surface within the Holocene Age (approximately the last 11,000 years) is considered active. The data examined and exposed by LGC Geotechnical's excavations does not definitively conclude that the area of proposed development is underlain by inactive or ancient faults, as datable materials were not identified which could constrain the age of the faults encountered. Therefore, it cannot be ruled out that an active fault may extend between the unfaulted materials exposed in Fault Trenches FT-2 and FT-3, which could also project south of the unfaulted southern portion of American Geotechnical's Fault Trench T-1 and connect to the primary trace of the Whittier Fault (Sheet 1). As a result, LGC Geotechnical recommends the following measures:

Recommended 75 Foot Structural Setback from Whittier Fault

Fault Trenching by LGC Geotechnical, No Evidence of Active Faulting

Recommended 50 to 100 Foot Structural Setback from Whittier Fault

Additional off-site fault trenching is recommended to determine the presence or absence of active faulting projecting towards the proposed development area within the Fault Rupture Hazard Zone shown on Sheet 1. If the proposed additional fault trenching finds unfaulted bedrock and/or faulted bedrock capped by old alluvial material, then it would show that the faulting encountered within Fault Trenches FT-1 and FT-4 is not active.

In the event the faults in FT-1 and FT-4 are not active, then a 75-foot fault setback zone would be recommended along the south side of the active Whittier Fault. This setback zone would be expected to have little effect on the development of the southern portion of the site (Planning Area 1). A 10-foot overexcavation and recompaction below pad grade for the proposed structures in the ridge area of the site closest to the Whittier Fault would be recommended in order to reduce the potential effect of the differential expansion of the steeply dipping bedding in this area. Post-tensioned (PT) foundations would also be recommended. The 10-foot overexcavation and use of PT foundations would also mitigate any potential impacts associated with minor movement along the old faults due to a major event on the Whittier Fault.

Should the faults be found to be active, it is recommended that the lots within the southern portion of the Fault Rupture Hazard Zone Area shown on Sheet 1 not receive residential building permits until studies are performed and the County determines which lots are suitable for residential construction (e.g., because additional study concludes that certain areas of proposed development are not underlain by an active fault.)

Immediately west of the site, previous fault studies have recommended a 100-foot-wide setback zone: 50 feet on either side of the primary trace of the fault and residential structures were accordingly set back from the active trace of the fault. North of the Whittier Fault, we recommend a setback zone in accordance with that recommended by American Geotechnical (AGI, 2012), ranging from 50 feet on the west side of the site to approximately 120 feet on the east side. The proposed development area north of the Whittier Fault (Planning Area 2) would be sufficiently located away from the fault so that the fault setback zone would not impact this portion of the proposed development.
